TECHNICAL MEMORANDUM

From: Jennifer Schmidt, Herrera Environmental Consultants

Subject: GIS Vulnerable Soils Risk Analysis Results

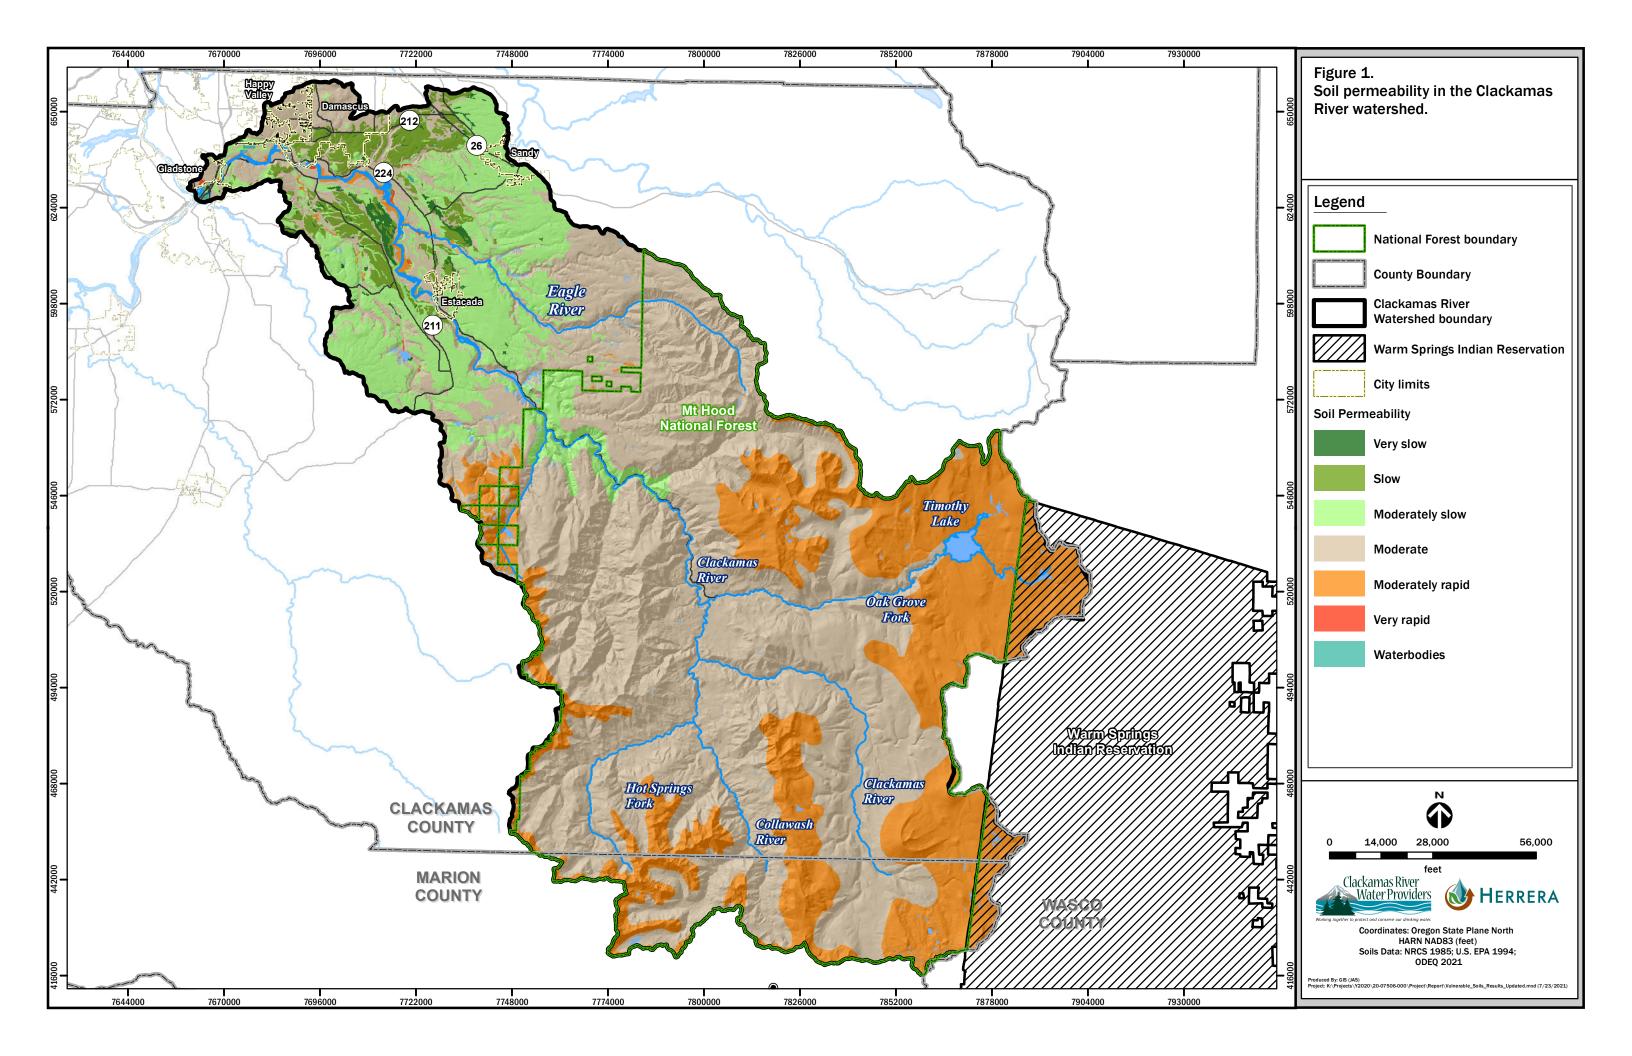
Figure 1 shows soil permeability rates within the Clackamas River watershed. Approximate acreages by permeability class are summarized in Table 1.

Herrera mapped soil permeability in the Clackamas River watershed based on GIS soil survey data and reports from the U.S. Department of Agriculture (USDA) National Resource Conservation Service (NRCS) and the U.S Environmental Protection Agency (EPA). Data mapped at a scale of 1:24,000 was used for the portion of the Clackamas River watershed north of Mt. Hood National Forest; data mapped at a scale of 1:250,000 was used for the remainder of the watershed, including the Warm Springs Indian Reservation. The difference in resolution between these datasets is important to consider when interpreting permeability patterns; accuracy may vary considerably between the survey areas.

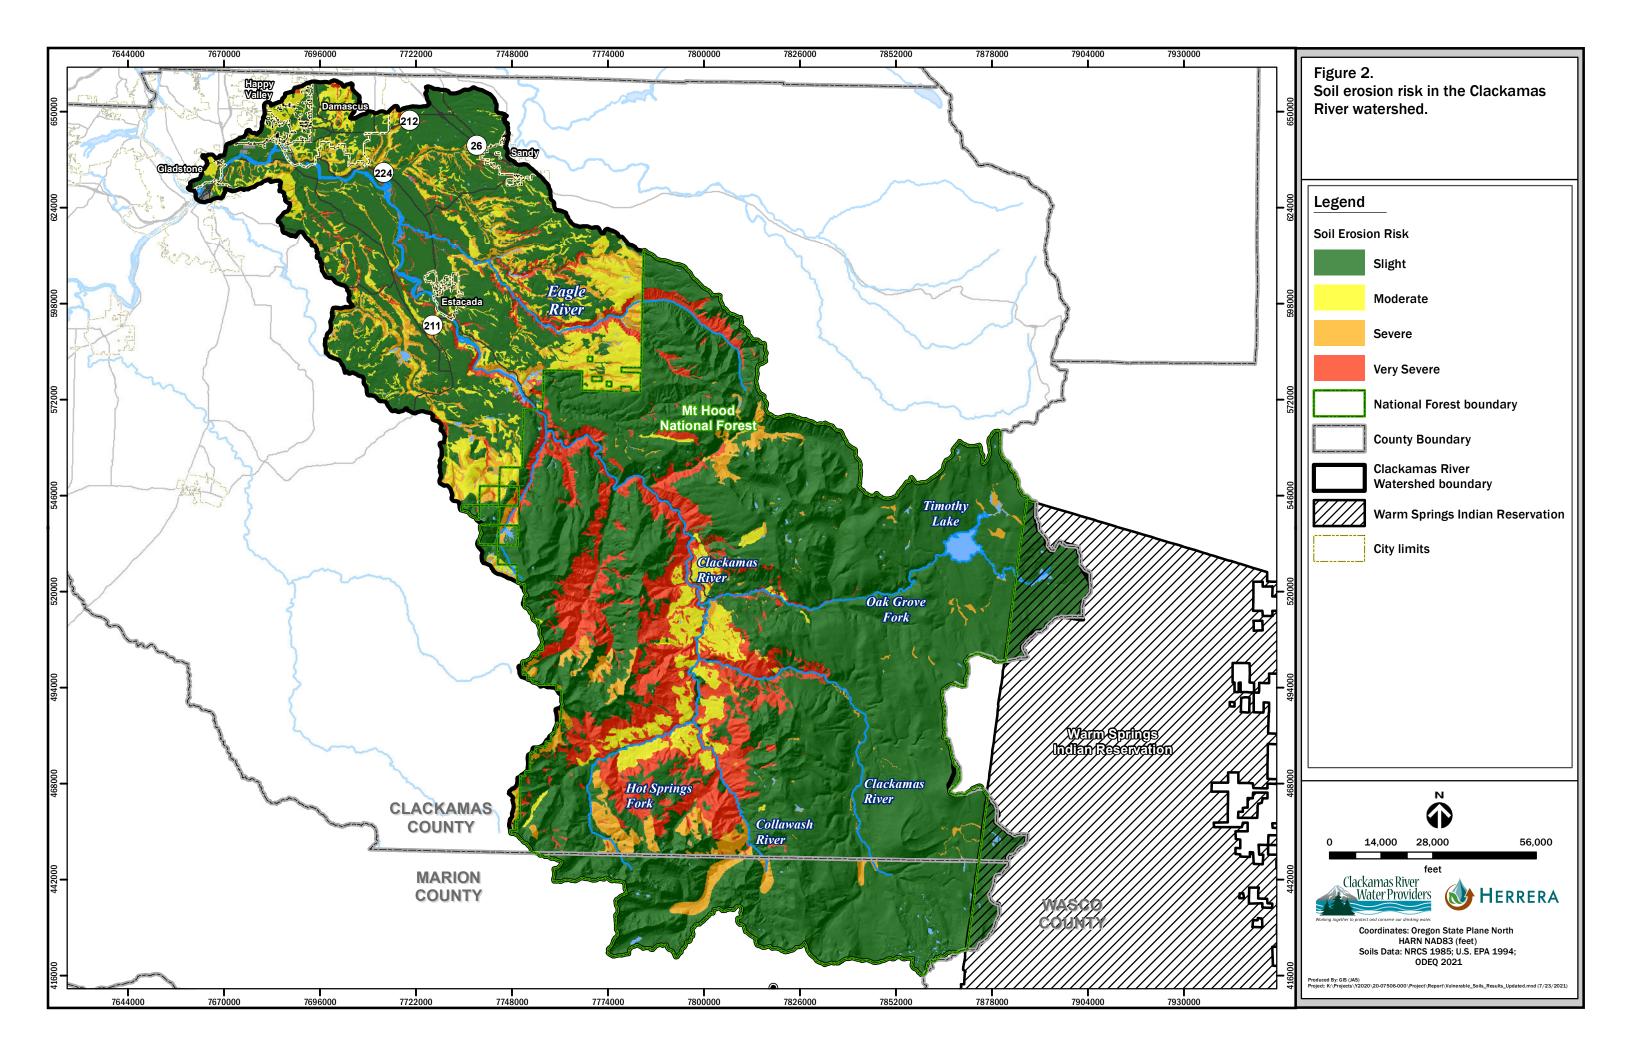
Figure 2 shows soil erodibility risk within the Clackamas River watershed. Table 2 summarizes acreages by risk category.

Herrera mapped soil erodibility in the Clackamas River watershed using four GIS data sources: 1) soil survey data and reports from NRCS mapped at a scale of 1:24,000 covering the portion of the watershed north of Mt. Hood National Forest; 2) spatial data depicting soil erosion potential prepared by the Oregon Department of Environmental Quality (DEQ) mapped at a scale of 1:250,000; 3) spatial data depicting erosion risk hazards mapped by Oregon DEQ at a scale of 1:24,000; and 4) soil survey data and reports from EPA mapped at a scale of 1:250,0000 for the portion of the watershed in Marion County. The difference in resolution between these datasets is important to consider when interpreting erodibility patterns; accuracy may vary considerably between survey areas.

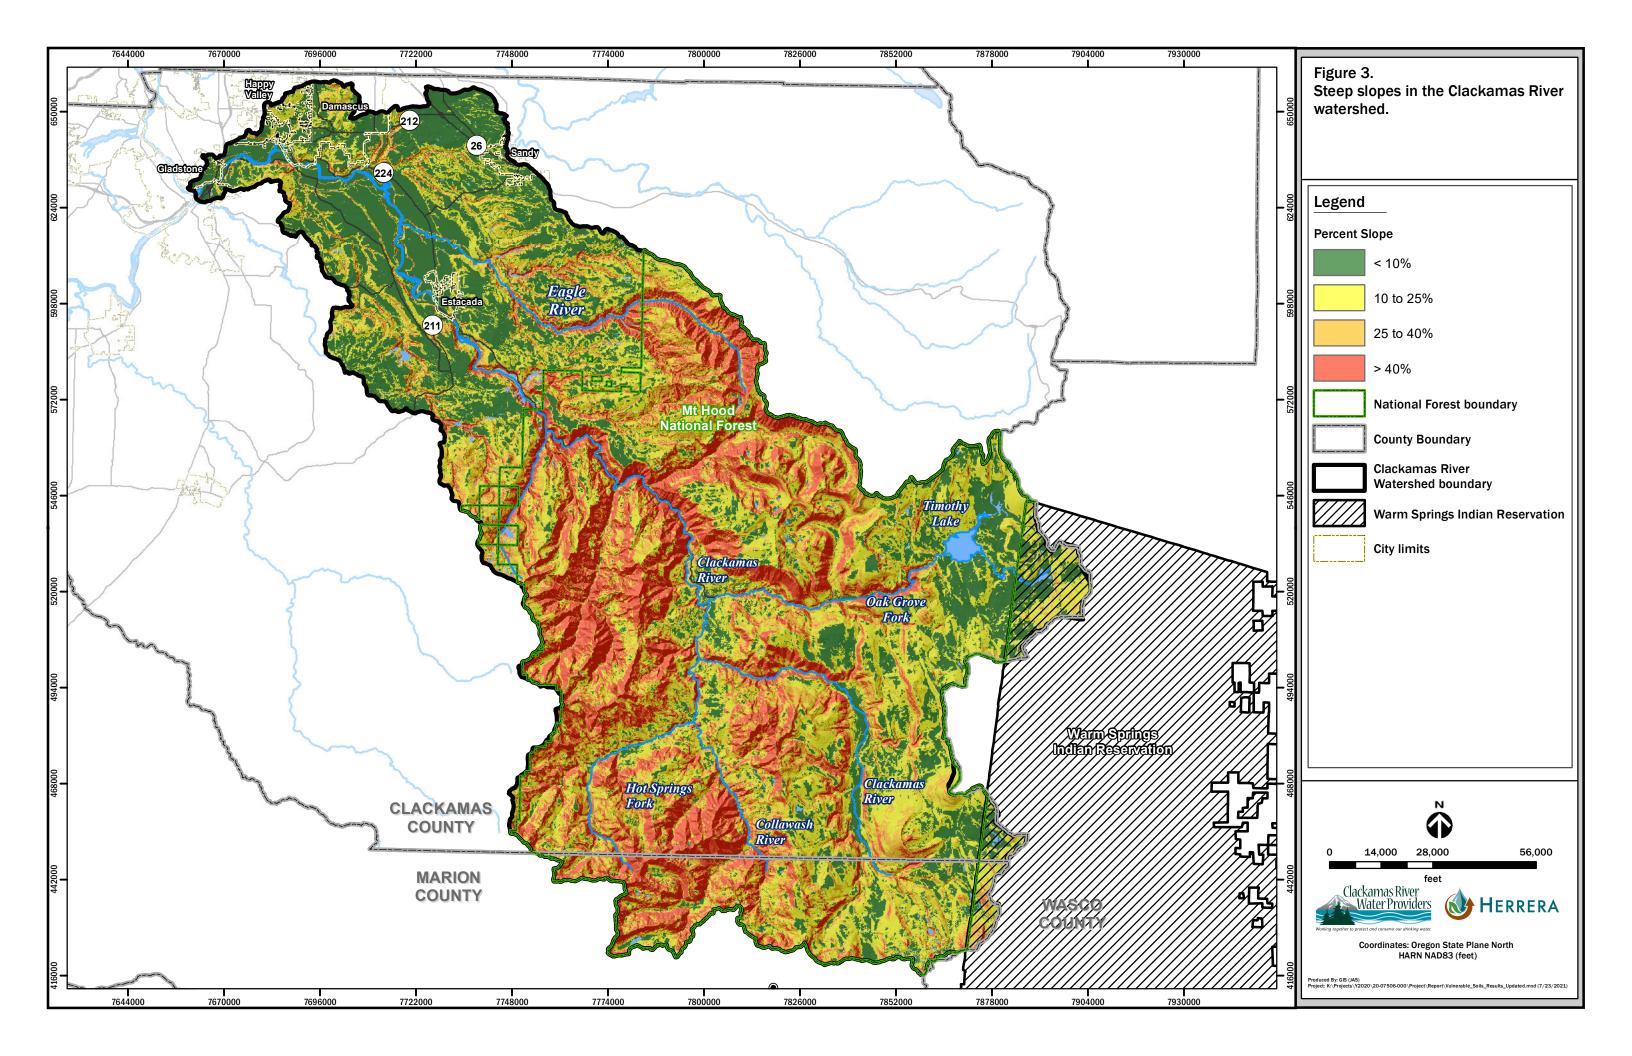
Herrera mapped steep slopes in the Clackamas River watershed using elevation data obtained from the United States Geological Survey (USGS) with a 10-meter pixel resolution. Figure 3 shows percent slope within the Clackamas River watershed; acreages by slope categories are summarized in Table 3.

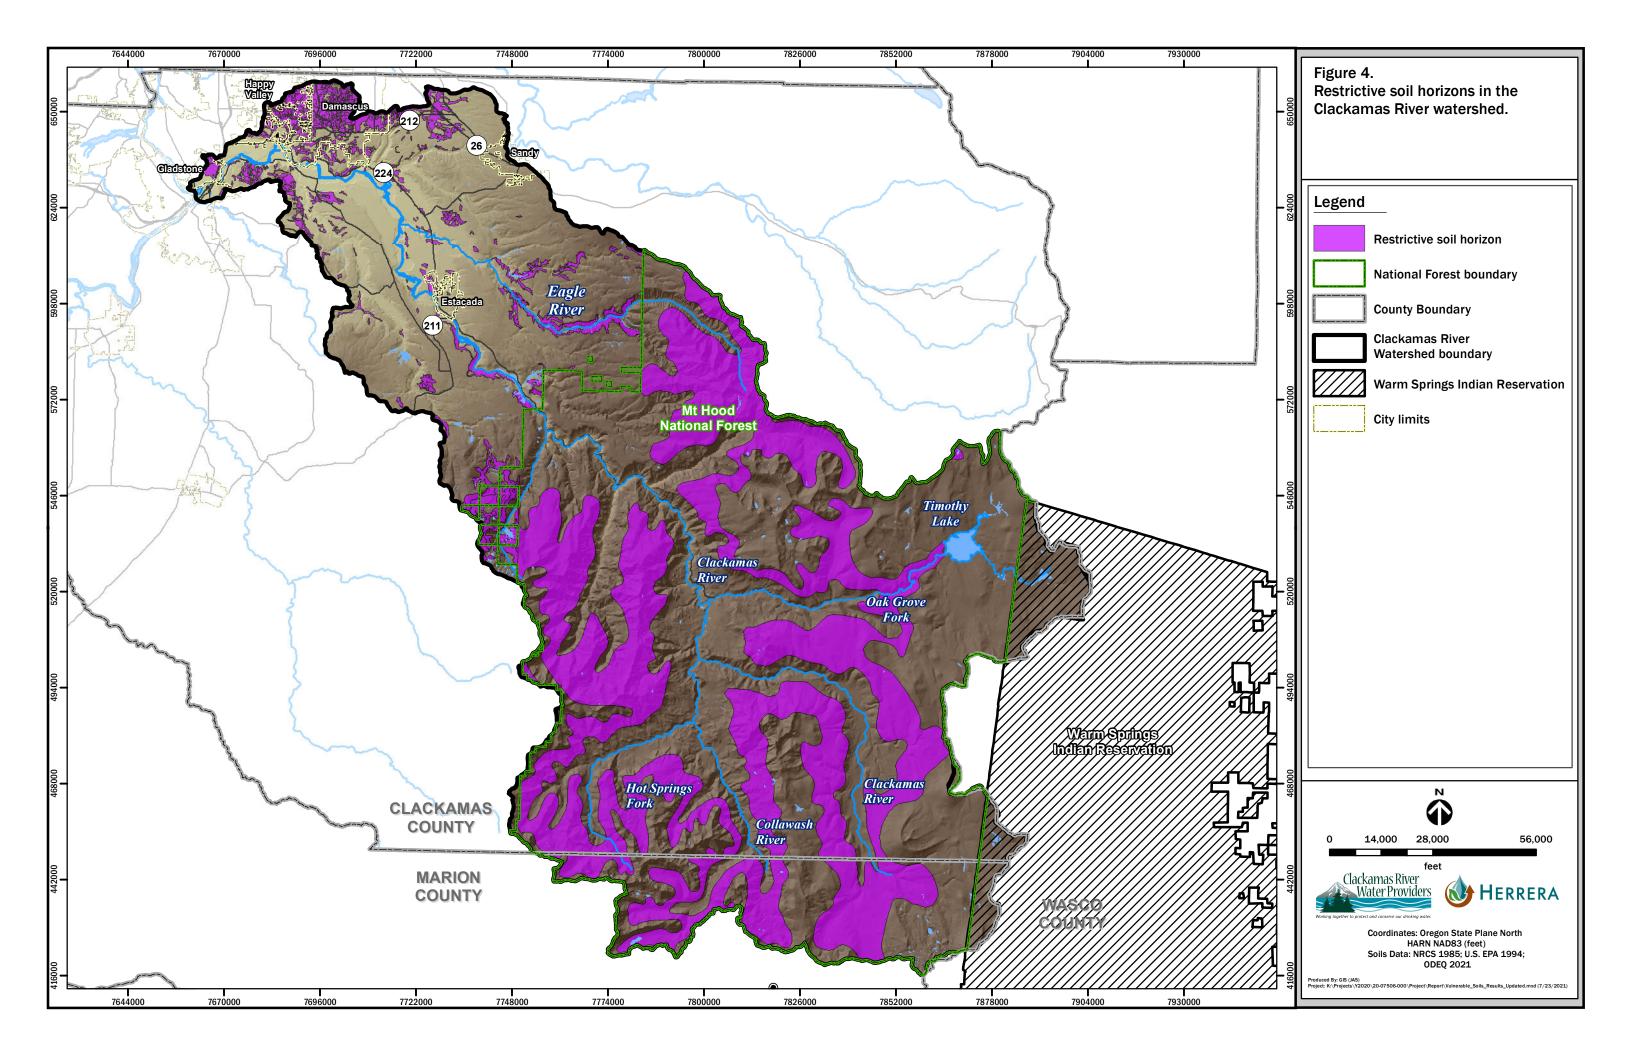
Herrera mapped restrictive horizons in the Clackamas River watershed based on GIS data and soil survey reports from NRCS and EPA. Data mapped at a scale of 1:24,000 was used for the portion of the Clackamas River watershed downstream of Mt. Hood National Forest; data mapped at a scale of 1:250,000 was used for the remainder of the watershed, including the Warm Springs Indian Reservation. Based on this data, approximately 186,530 acres (30%) of the watershed contains soils with restrictive horizons that are largely impervious to water; the distribution of these areas is shown in Figure 4. The difference in resolution between the source

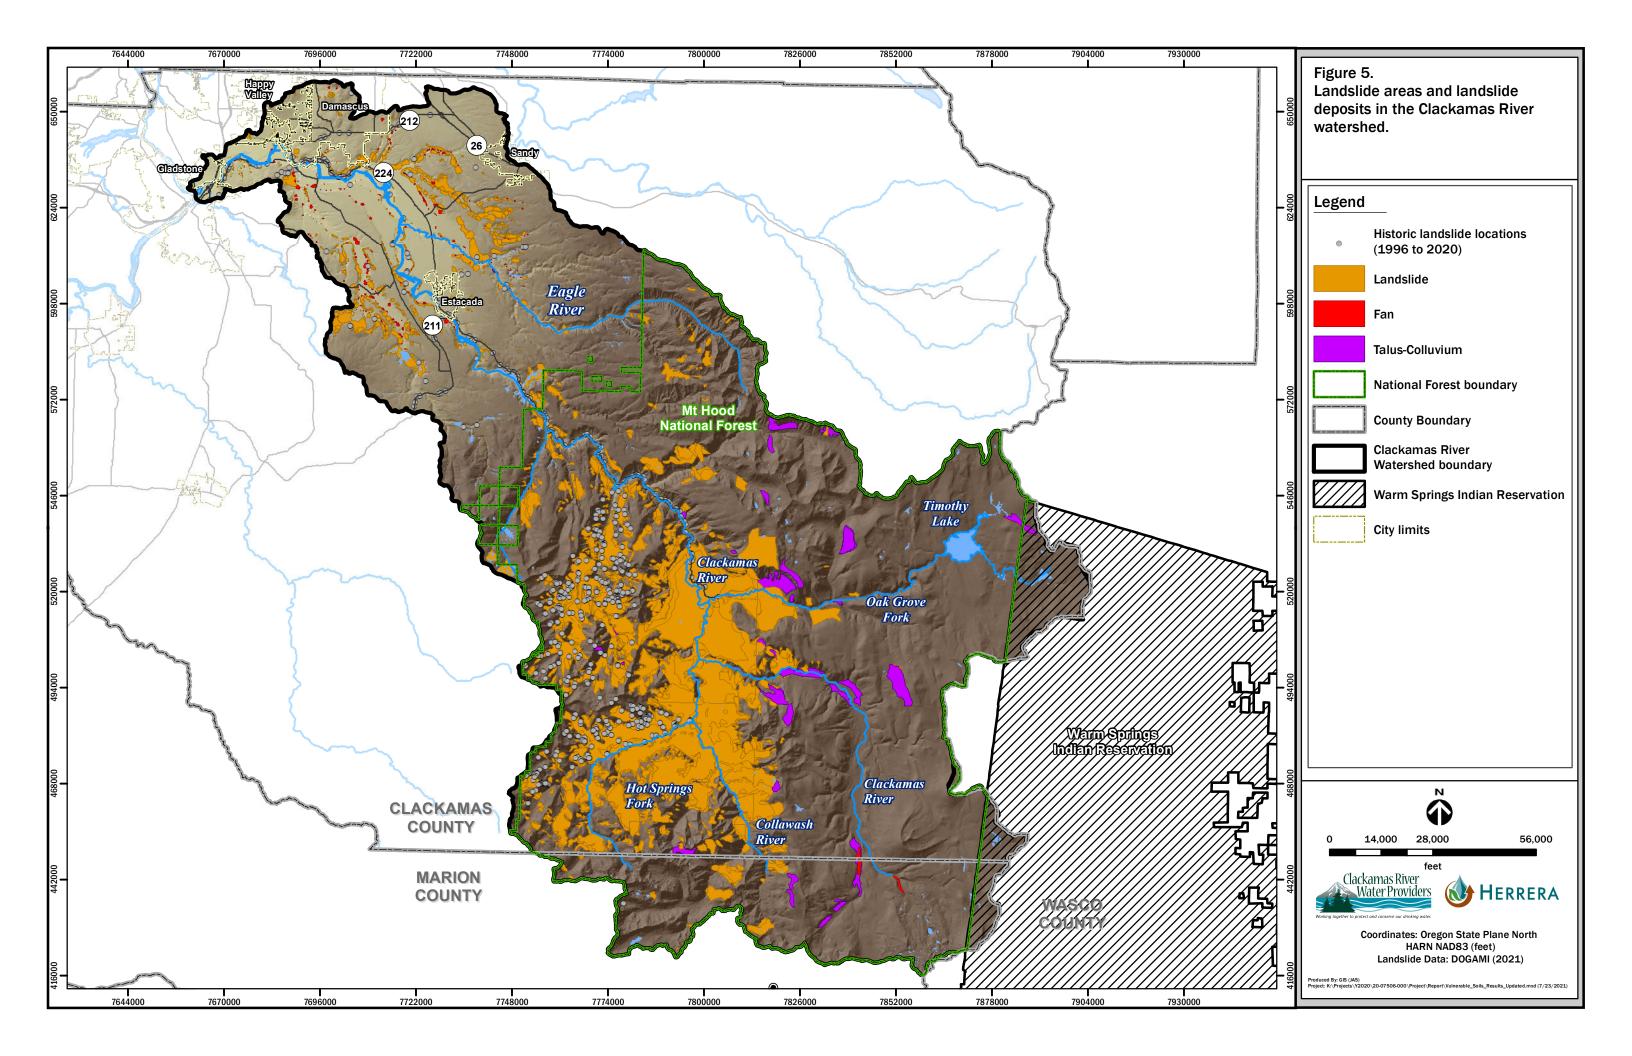
Landslides generate large quantities of sediment, posing a significant risk to water quality as the sediment moves downhill and into rivers and streams. Herrera mapped landslide areas in the Clackamas River watershed using the Statewide Landslide Information Database for Oregon (SLIDO-4.2) from the Oregon Department of Geology and Mineral Industries (DOGAMI), which is a database of landslides and landslide-related features compiled from over 300 published and unpublished geologic hazard studies. Approximately 2,500 landslide deposit and landslide-related features and 620 historic landslide point locations were mapped by DOGAMI in the Clackamas River watershed. These features are shown on Figure 5.
